# Manhole Inspection Summary

Manhole # S04EE2004MH

Insp Date: **7/13/06 12:22 PM**

**Location** Address: **3500 FALLSTAFF RD**

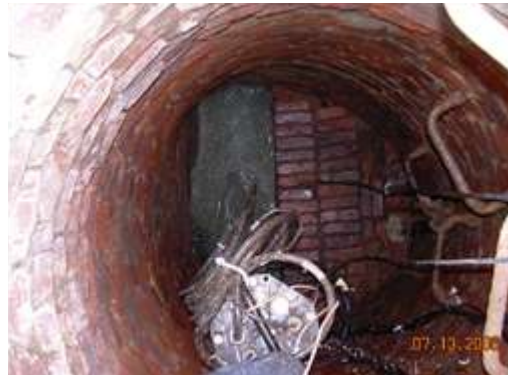
Top View

Evidence of surcharge. Corroded steps.

offset joint and lining in O12

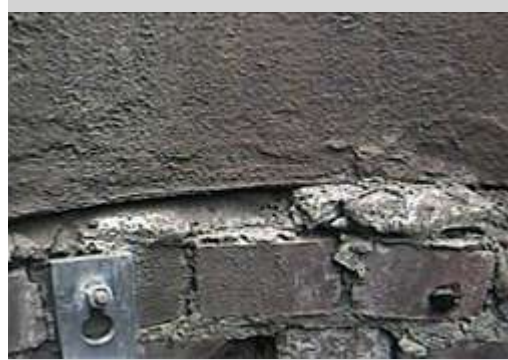
Defect

Frame leaks. Adjustment deterioration and loose brick. Adjustment infiltration.

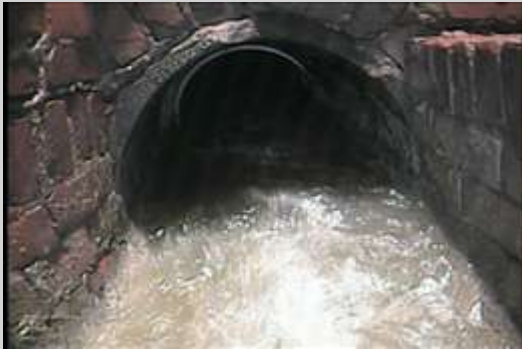
### 18 in. Circular Gravity Sewer Pipe Out @ 12 O'Clock

Infiltration: **Evidence** Pipe Seal Cond: **Cracked**
